# **Non-destructive Evaluation of Aircraft Structural Components and Composite Materials at DSTO Using Sonic Thermography**

***Kelly A. Tsoi and Nik Rajic***

**DSTO–TN–0986**

## **ABSTRACT**

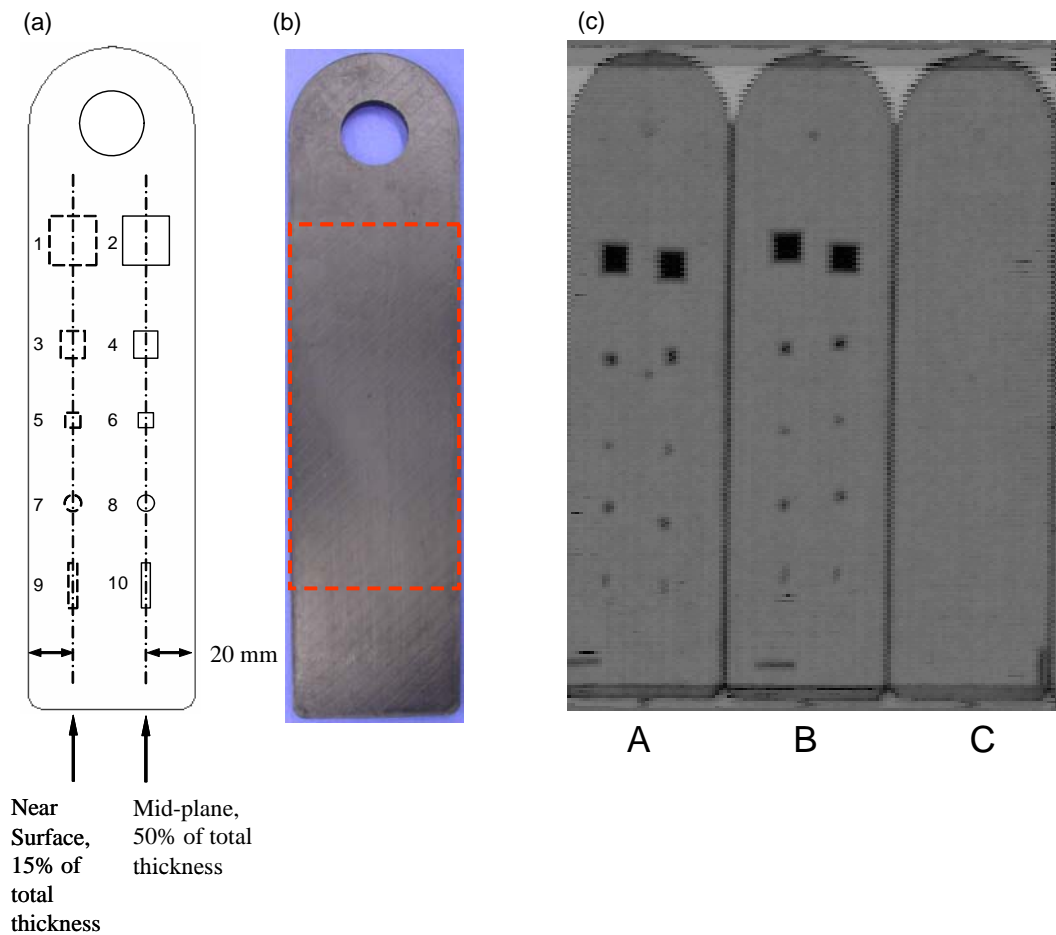
**Figure 4:** (a) Diagram of the insert positions embedded in the mid plane, 50% of the total thickness of the laminate and in the near surface, 15% of the total thickness, (b) photograph of the specimen, the outline in red shows the inspection area and (c) through-transmission ultrasound image showing insert locations in specimens A, B and C, from the reverse side of the specimens, as indicated (courtesy CRC-ACS).

The difficulty in detecting the smaller inserts at a depth 15% below the surface (5, 7 and 9) and the majority of the inserts embedded in the midplane of the specimen (4, 6, 8 and 10) is due, in part, to the fundamental sensitivity limitations of thermographic techniques. According to Maldague [14], a rough rule of thumb for a defect to be detectable using active thermography is that its effective radius should be at least as large as its depth beneath the surface. A summary of the insert sizes for the case in hand, based on this general rule, is shown in Table 2, where the relevant lateral dimension is taken to be the effective radius. The ‘depth’ shown in Table 2 gives the minimum depth at which the inserts in these specimens should be detectable. Based on these results, it can be seen that the inserts embedded at a depth of 15% below the surface should be detectable, and the PPT results for the ST and FT inspections substantiate this. For an embedment depth of 50%, the two largest defects (2 and 4) should be observable, whilst the rest of the defects are below the detection limit. In the ST inspections of specimen B it is possible to detect insert 2, as can be observed in the PPT result and all modes of the PCT results, and insert 4 is observable in the PCT<sub>5</sub> result. Interestingly, insert 8 is just observable in PCT<sub>5</sub>, even though it is below the minimum detectable limit given by Maldague [14].

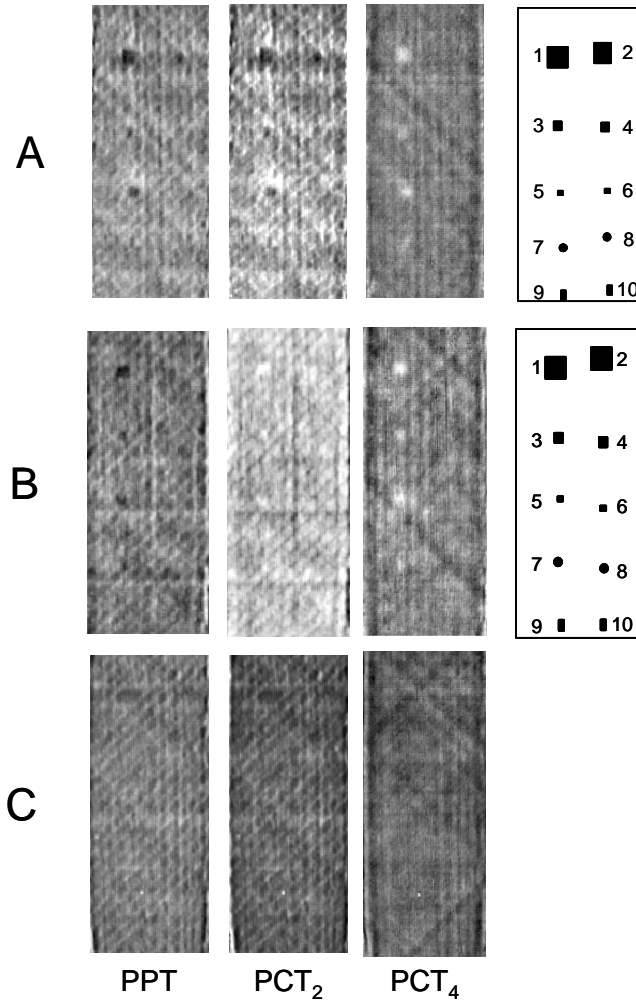
**Figure 6:** FT inspection of the thin film insert specimens. Specimens A, B and C are indicated, and the PPT, and PCT results for modes 2 and 4, are shown. The defect positions for specimens A and B are shown to the right of the thermographs.

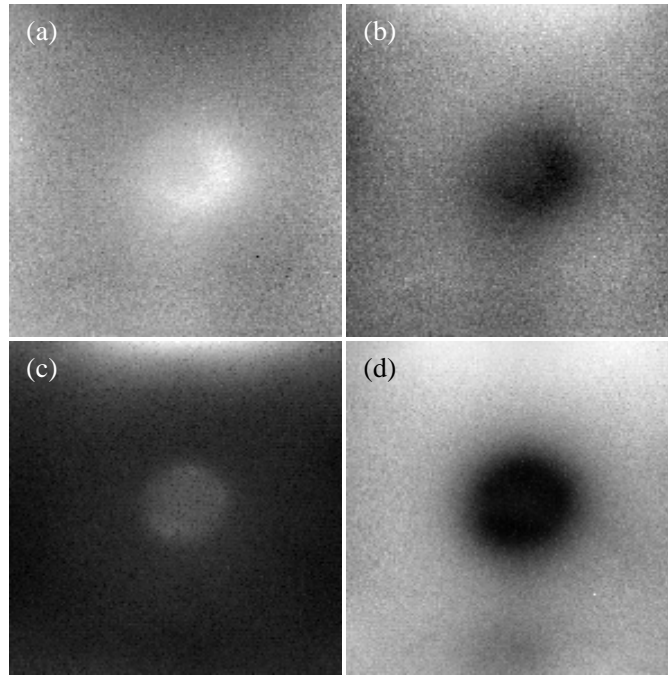
**Figure 12:** *PPT (left) and  $PCT_2$  (right) results of glass reinforced aluminium specimens with embedded Teflon inserts captured with the inserts below the E-glass-fibre (a-b) and above the E-glass-fibre (c-d).*

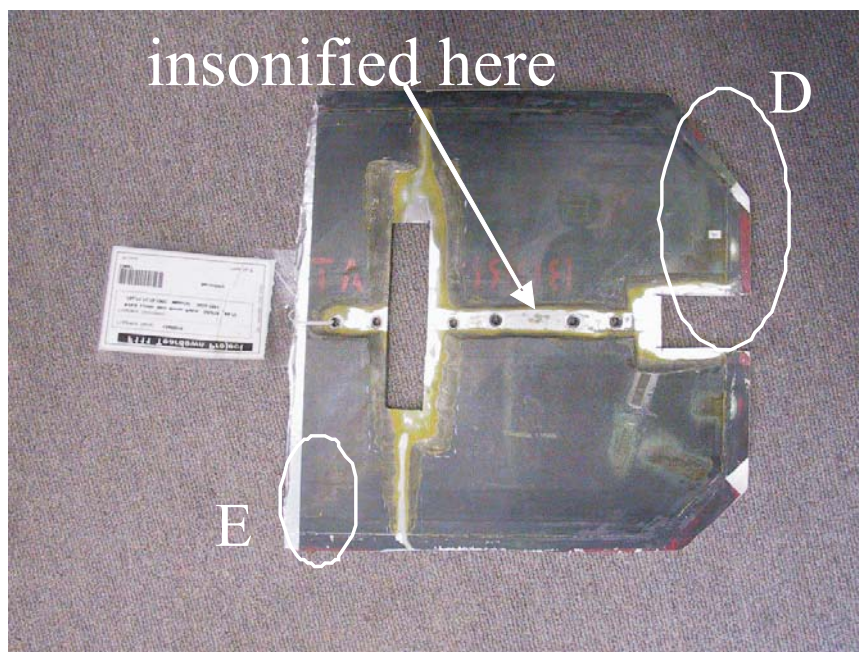
A photograph of the other LWS fragment, 12W951X, is shown in Figure 18 and Figure 19 shows the PCT results (a, b, d and e) and corresponding flash thermographs (c and f) for regions D and E, as indicated. It is noted that a non-grey colour map is used in this case merely to accentuate indications, and does not indicate relative temperature; that is whether a region is hotter or colder. The PCT results show clear indications of disbonding (circled) which are not as strong in the FT results (c and f). Once again the spatial detail is superior in the ST results.

**Figure 18:** Photograph of fragment 12W951X, indicating regions of interest, D and E and point of insonification.

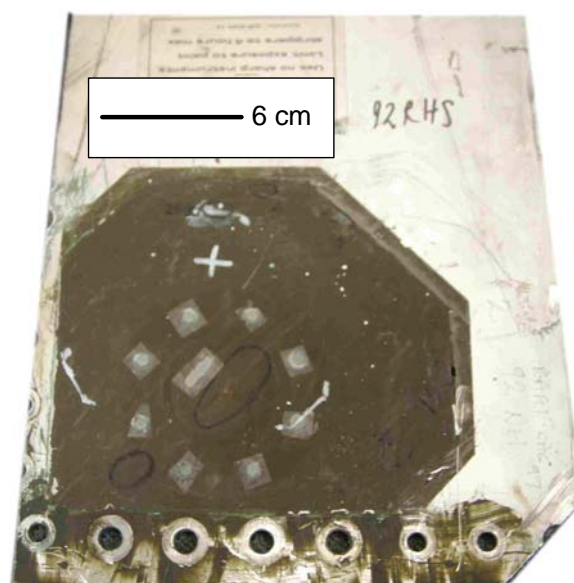
Figure 21 shows a photograph of a typical Mirage patch under investigation. Figures 22(a) and (b) show the flash PPT and sonic PCT<sub>2</sub> results of the patch, respectively. Figures 22 (c) and (d) show the results obtained using the bandicoot system, in which the peak defect index was set to 4% at 9-15 kHz in (c) and 2% at 25-35 kHz in (d). The indicated areas in Figure 22(b) show regions of elevated heat generation corresponding to possible defects. While the FT scan does contain some contrast in the regions shown by ST to be flawed, the indications are quite diffuse and difficult to interpret. The BaNDIcoot system

**Figure 21:** Photograph of a typical Mirage III boron patch under investigation.

revealed several suspect sites in areas broadly consistent with the ST result, however the scan indicates a more localised distribution of damage than that suggested by ST.

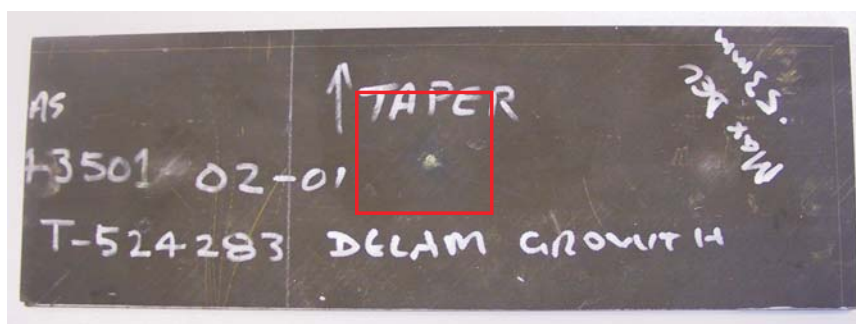
The second C/Ep specimen had a single BVID also with 8 J initial impact energy. The specimen was also insonified for 5 s with the acoustic horn set to 500 W with 300 frames captured at a frequency of 10 Hz. Figure 24 shows the specimen with the impact region marked by the square. Figure 25 shows the (a) sonic PPT, (b) sonic PCT<sub>3</sub> and (c) flash PPT results. Normally, processing the raw thermographic data would eliminate most emissivity related features, however in this case, the ink markings on the specimens are still apparent in the FT result, though this has had a negligible impact on the detectability of the flaw.

**Figure 24:** Photograph of the single impact specimen with the impact region indicated by the square.

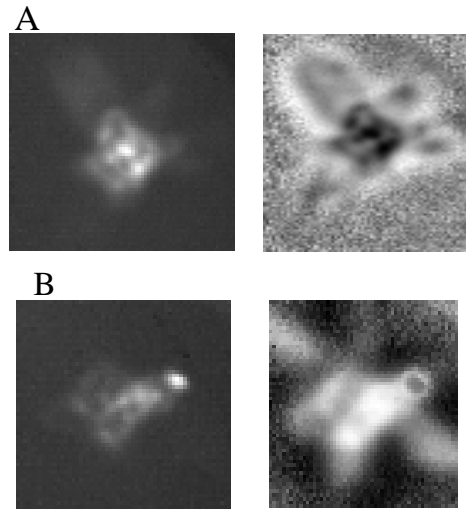
**Figure 27:** Raw ST (left) and  $PCT_2$  (right) results, respectively, for Syncore specimens A and B.

Impact damaged specimens made with ‘Syncore’, a registered trademark of Loctite aerospace, were investigated. Syncore is a toughened, low density epoxy syntactic core material, of foam-like appearance, that is designed to be sandwiched between composite face skins to create a structural panel with a high strength to weight ratio. One of the main concerns with this advanced material is its questionable impact resistance. In a preliminary study on its impact resistance several specimens were manufactured, exposed to a controlled impact and then non-destructively inspected. Two samples were made available for thermographic inspection. In preliminary testing it was found that only a relatively short insonification ( $< 0.5$  s) was required to produce a strong indication of damage. The unprocessed and  $PCT_2$  results are shown in Figure 27 for the two samples. The results show that even an unprocessed thermograph renders a strong indication of subsurface damage. The panel appears to be an ideal candidate for thermographic inspection as the core seems to suffer profound damage under impact, leading to a large thermal signature, while the thin composite skin presents little obstruction to the transfer of heat from the core to the specimen surface.

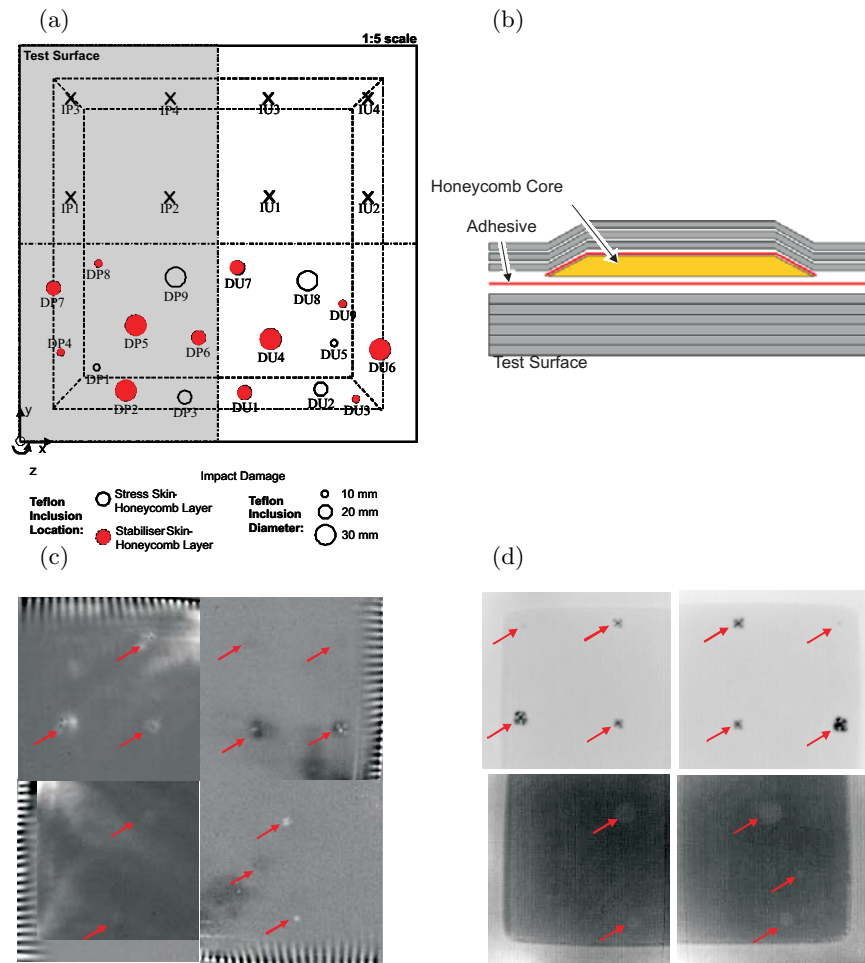
**Figure 30:** (a) Damage map, (b) profile image of layup, (c) sonic and (d) flash thermographs showing the four quadrants of specimen 2A and the corresponding damage locations. (Specimen layout courtesy CRC-ACS.)

Figure 30 shows the ST and FT results for specimen 2A and the corresponding damage map. Specimen 2A is a honeycomb reinforced panel with the reinforcement confined to the region of the panel within the outer dashed line of Figure 30(a). The area between the dashed lines corresponds to a sloping section of the honeycomb structure as shown in Figure 31. Inclusions were located between the honeycomb core and stabilising skin, as well as between the honeycomb core and the stress skin, both shown in Figure 31. Inclusions were also located on the sloping edge between the honeycomb core and stabilising skin. Table 7 shows the theoretical detectability of disbonds based on the rule of thumb described in section 3.2. These results indicate that all disbonds located in the stress skin/honeycomb layer are, in principle, detectable. Disbonds located in the stabiliser skin/honeycomb layer, are not detectable, however 30 mm defects located in the sloping edge should be detectable and 20 mm defects in this region should be partially detectable. The thermographs indicate this to be the case with only DP1 not detected. DP2 was located using ST only. As with specimens 1A and 1B, the addition of the Cu mesh in the skin reduces the detection rate for the reasons already outlined for specimen 1B (see Figure 32).

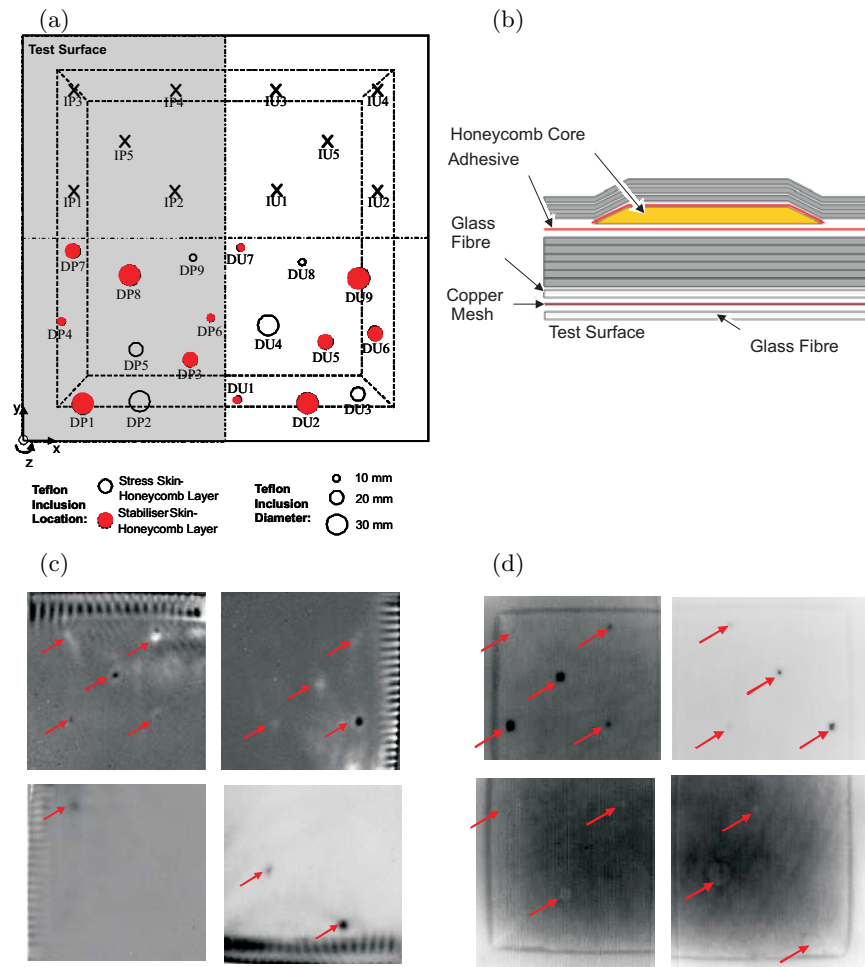
**Figure 32:** (a) Damage map, (b) profile image of layup, (c) sonic and (d) flash thermographs showing the four quadrants of specimen 2B and the corresponding damage locations. (Specimen layouts courtesy CRC-ACS.)

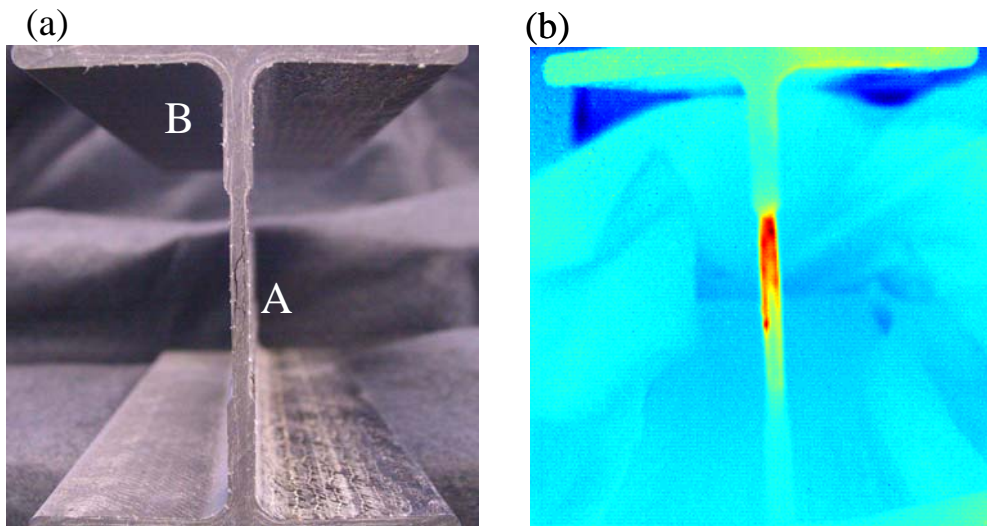
Region A of the first I-beam inspected showed visible damage in the web and during insonification this damage was clearly observed as a region of increased heat production as shown in Figure 34(b). For this particular I-beam no damage was found in region B. Region B of the second I-beam showed some signs of cracking along the exposed surface of the flange. During insonification further internally located damage was detected. Figure 35 shows a photograph of the section under investigation (top) along with the sonic PCT<sub>3</sub> result (middle). The bottom image shows the sonic PCT<sub>3</sub> result for a reference specimen with no observable cracks.

**Figure 34:** (a) Photograph of I-beam showing the regions of interest, A and B, and (b) the corresponding sonic thermograph.

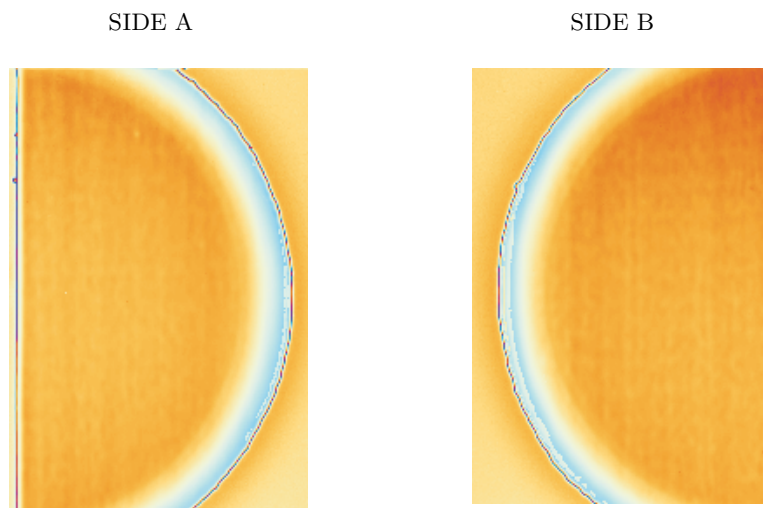
Figure 37 shows the flash PPT results for sides A and B (as indicated). No indications of a defect are present. Figure 38 shows the ST raw image, PPT and PCT<sub>2</sub> results pertaining to sides A and B for insonification at point a and Figure 39 shows the ST raw image, PPT and PCT<sub>2</sub> results for insonification at point b. The differences between the two points of insonification are marked. Two distinct mode shapes are evident in the series: the horizontally banded pattern in Figure 38, and the more complex pattern shown in Figure 39. It is important to note, however, the consistency of the vertical indication extending upward from the base of the patch. This indication corresponds well to the location and length of the underlying crack. Figure 40 shows the results (both PPT and PCT) of insonification at the four different points (as indicated in Figure 37) on side A. The result suggests that defect indications may be distinguished from vibrational mode patterns by performing a cross-correlation between inspections where different mode shapes are excited (also mentioned in Section 3.7).

**Figure 37:** FT PPT results of sides A and B of the B/Ep patched honeycomb panel.

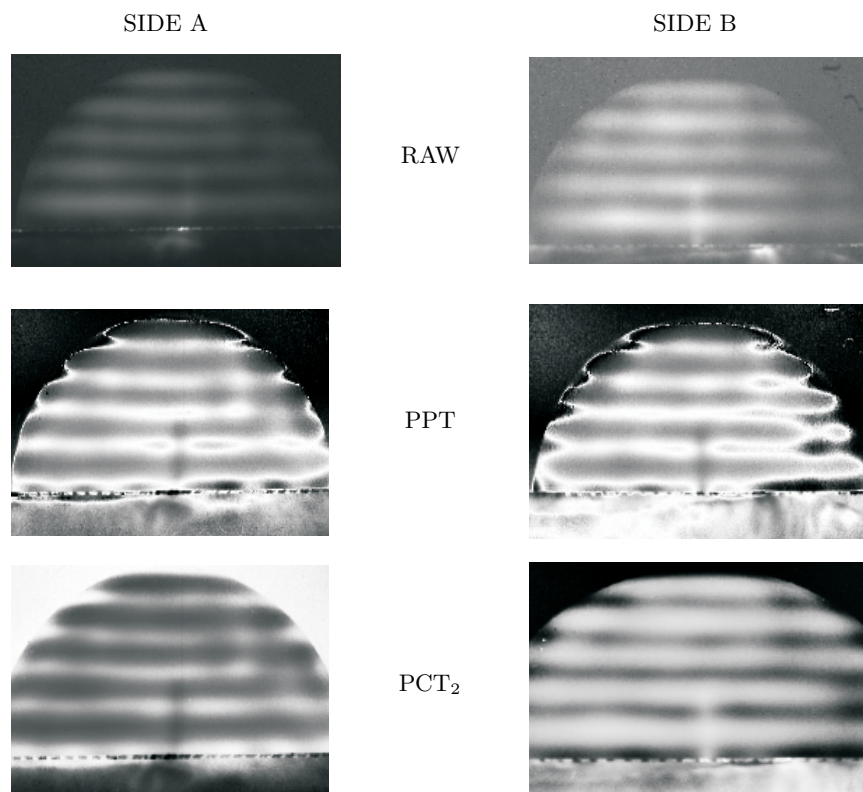
**Figure 38:** *ST raw, PPT and PCT<sub>2</sub> results of the B/Ep patched honeycomb panel insonified at point a (indicated in Figure 36).*

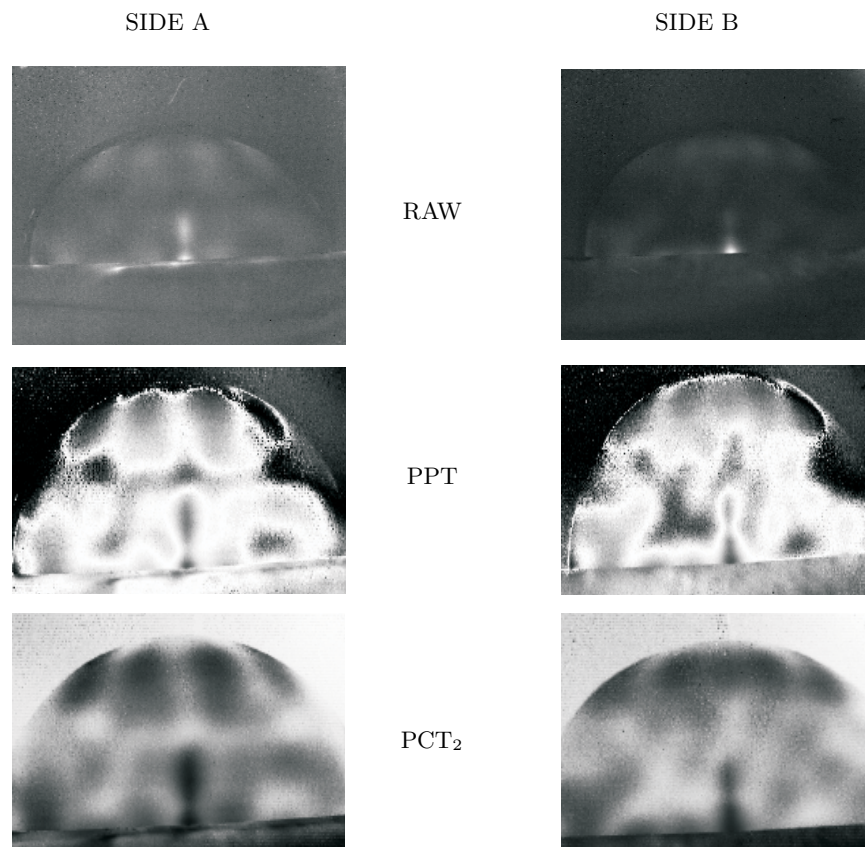
**Figure 39:** *ST raw, PPT and PCT<sub>2</sub> results of the B/Ep patched honeycomb panel insonified at point b (indicated in Figure 36).*

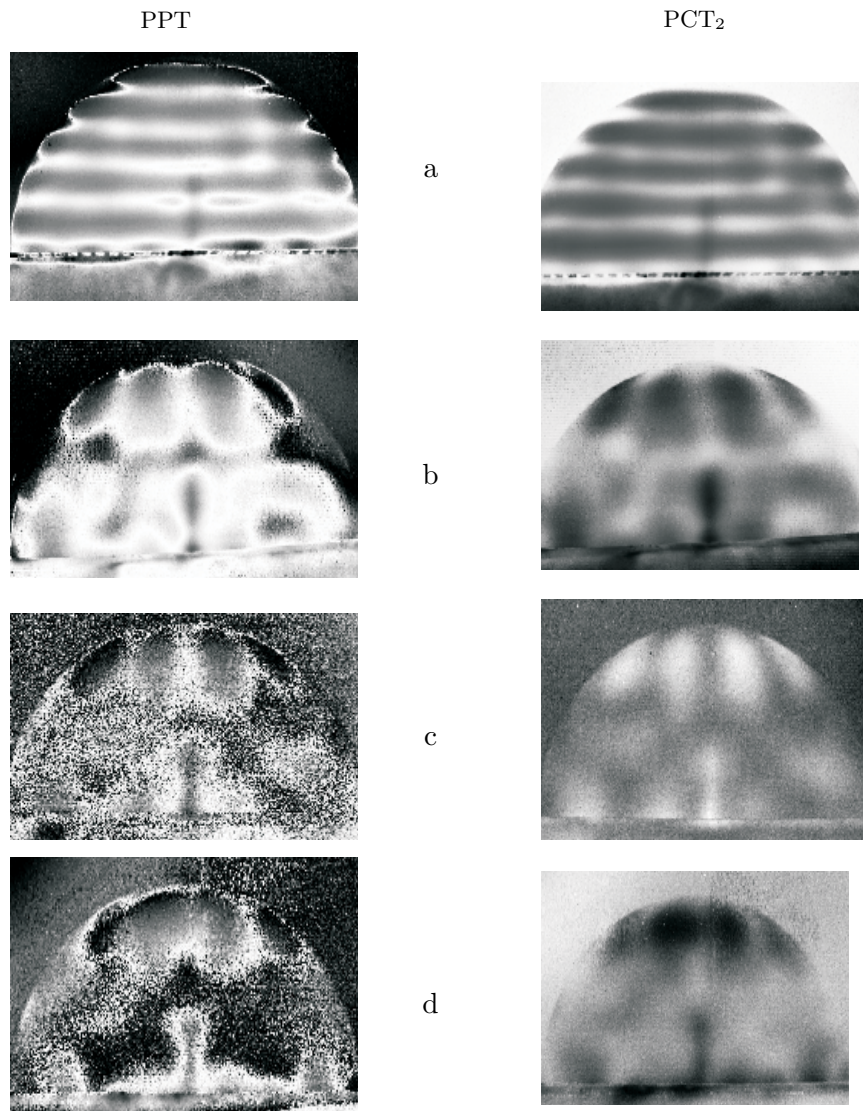
**Figure 40:** ST PPT and PCT<sub>2</sub> results of B/Ep patched honeycomb panel insonified at four locations (a, b, c and d) on side A, as indicated, corresponding to Figure 36.

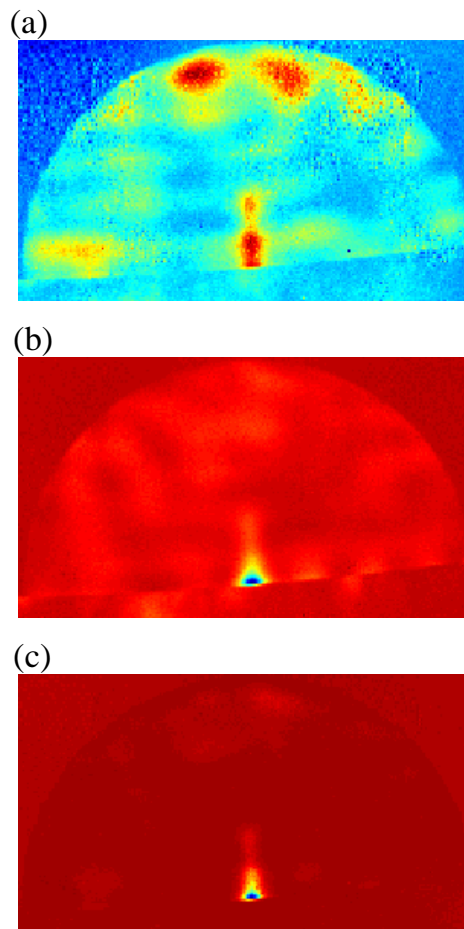
Figure 41 shows an example of a cross-correlation between two PCT<sub>2</sub> results. The two results were drawn from insonifications at points a and e, as indicated in Figure 36. The result shows the effectiveness of this simple image processing step in delineating the crack signature from the vibrational mode patterns.

**Figure 41:** (a) and (b) show the  $ST\ PCT_2$  results of  $B/Ep$  patched honeycomb panel insonified on side A at locations a and e, respectively, corresponding to Figure 36. (c) is the cross-correlation result of the two  $PCT$  results.

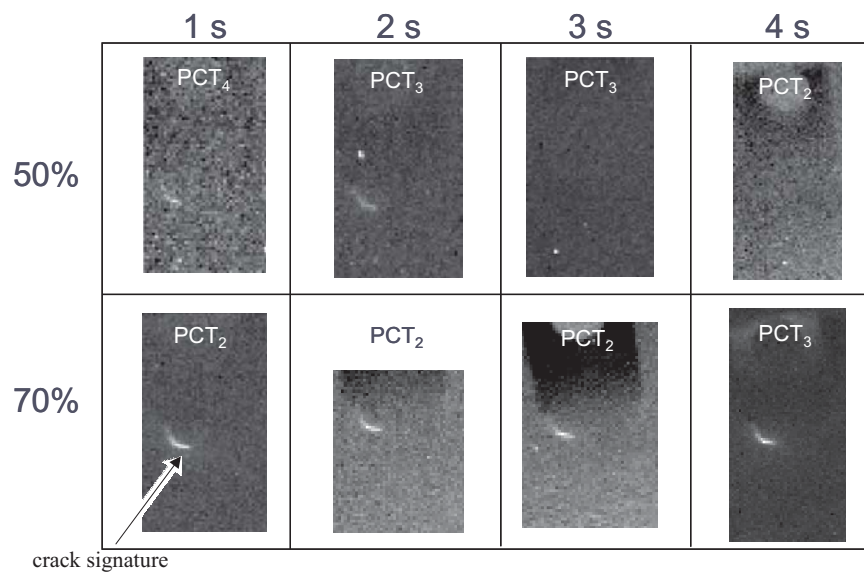
A study on the effect of power level on the IR signature was conducted. Levels of 600 W (50% of the total available power), 840 W (70%) and 1200 W (100%) were considered. Stem 1 was made the subject of the study as this stem had cracking which was not visible. The interface material was found to disintegrate at the 1200 W (100%) level and was, therefore, not considered a useful level for routine inspection. The results, shown in Figure 46, indicated that 840 W (70%) was sufficient to obtain a clear, reliable IR signature from the cracks and had a negligible effect on the interface layer. This power level was used for all inspections of the wheel.

A sensitivity study was also undertaken on stem 1 to examine the effect of insonification time on signal quality. The results are also shown in Figure 46. Generally, an insonification time of 1-2 s was enough to produce reliable indications, however a 4 s duration was found to provide marginally stronger signals and was therefore used throughout this study.

**Figure 46:** PCT results for stem 1 indicating varying insonification times (1 s, 2 s, 3 s, 4 s) and power levels (50% and 70%).

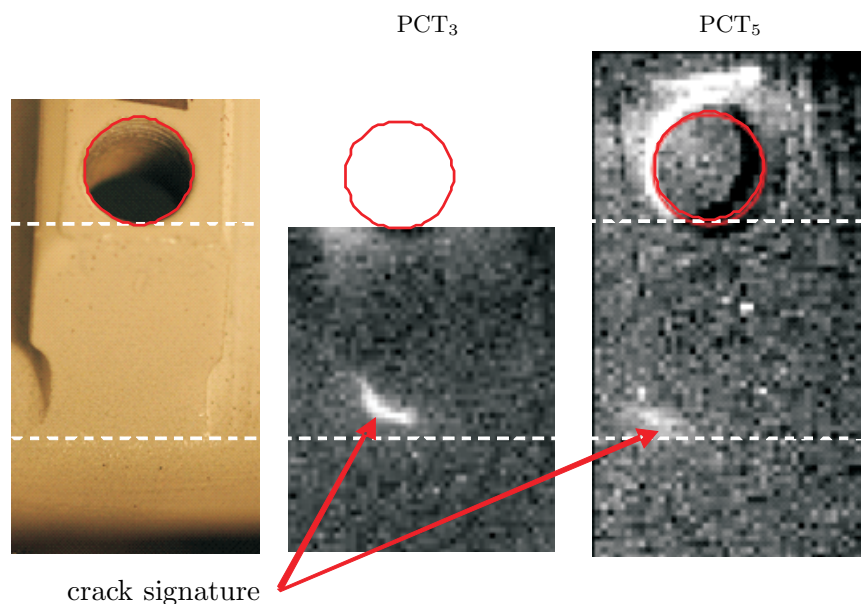
**Figure 47:** Stem 1: photograph and PCT results for the painted (left) and unpainted area (right), respectively.

Figure 47 shows a photograph of the area of interest and the PCT results for the painted and unpainted cases, respectively. The parallel white lines are used to align the photograph with the PCT results and the red circles indicate the position of the hole at the top of the stem. There was no visible evidence of cracking and it should be noted that any existing cracks may be masked by the white surface coating of the rim. The PCT results for the painted and unpainted cases show the thermal indication of a crack on the bottom left corner of the stem. Although the painted case shows greater definition, the unpainted case also provides evidence of the crack.

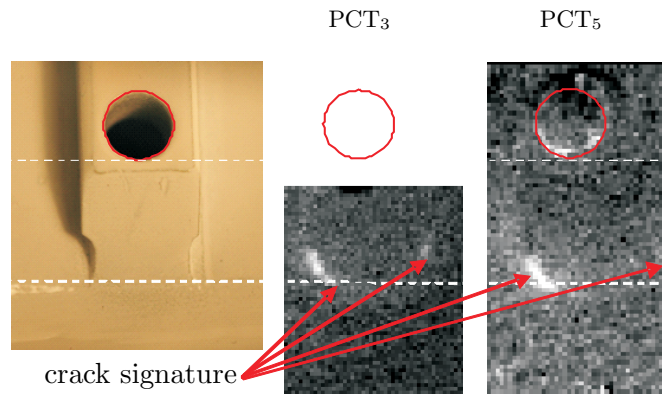
Figure 48 shows a photograph of stem 2, and the PCT results for painted and unpainted cases. Once again, no visible evidence of cracking is observed. The PCT results indicate cracking on both corners of the stem, with little difference between the painted and unpainted cases.

**Figure 48:** Stem 2: photograph and PCT results for the painted (left) and unpainted area (right), respectively.

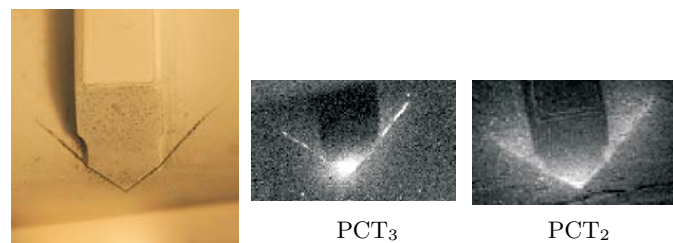
**Figure 49:** Stem 3: photograph and PCT results for the painted (left) and unpainted area (right), respectively.

Figure 49 shows stem 3, along with the painted and unpainted PCT results. This stem exhibited a large, visible crack. The crack had grown through the wall of the main wheel rim. The PCT results for both painted and unpainted cases show a substantial thermal response from the crack, as expected from a defect of this size.

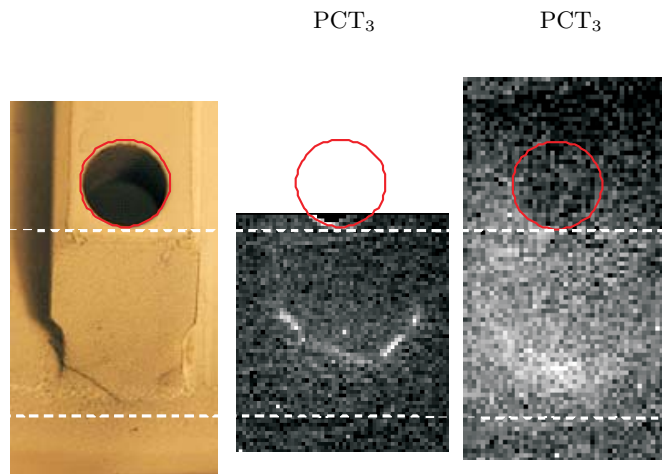
Figure 50 shows a photograph of stem 4 and the PCT results for the painted and unpainted cases. This stem had no visible cracking. For the painted case insonification provided a strong indication of cracking at both corners of the bottom of the stem. Although a thermal indication also appears for the unpainted results, it is not as well defined as for the painted results.

**Figure 50:** Stem 4: photograph and PCT results for the painted (left) and unpainted area (right), respectively.

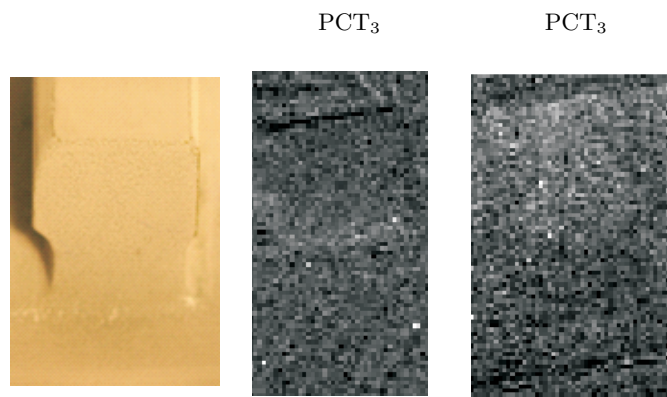
Figure 51 shows the photograph of stem 5 and the PCT results for the painted and unpainted cases. This stem had no visible cracking. The PCT results gives no indication of cracking at the corners of the stem.

**Figure 51:** Stem 5: photograph and PCT results for the painted (left) and unpainted area (right), respectively.
